## Photographic Log

<b>Client Name:</b> Robert Manseau		<b>Site Location:</b> 54 Lake Attitash Road Amesbury, Massachusetts	<b>Project No.</b> 01.0175290.00
<b>Photo No.</b> 1	<b>Date:</b> 8/17/21	 	
<b>Direction Photo Taken:</b> Northwest			
<b>Description:</b> View looking along shoreline to the north of the dock, note stone wall along toe of slope. Also note wood stairs to dock.

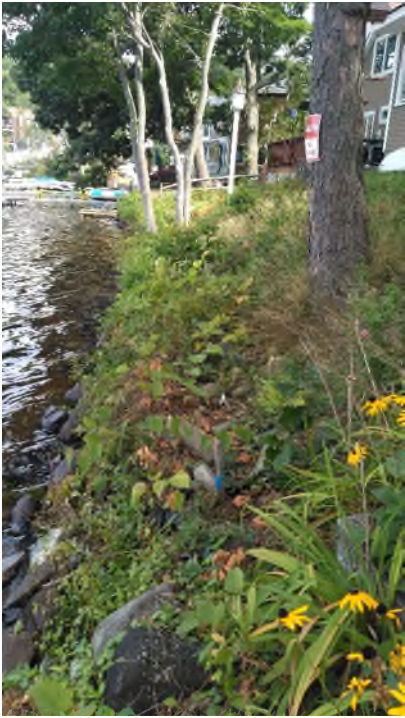
<b>Client Name:</b> Robert Manseau		<b>Site Location:</b> 54 Lake Attitash Road Amesbury, Massachusetts	<b>Project No.</b> 01.0175290.00
<b>Photo No.</b> 3	<b>Date:</b> 8/17/21

A vertical photograph showing a stone wall along a slope. The wall is made of large, dark stones. In the foreground, there are green plants and yellow flowers. In the background, there are trees and a building.	
<b>Direction Photo Taken:</b> Northwest			
<b>Description:</b> View along toe of slope. Note stone wall in fore and midground. Also note several stones have fallen from the wall.

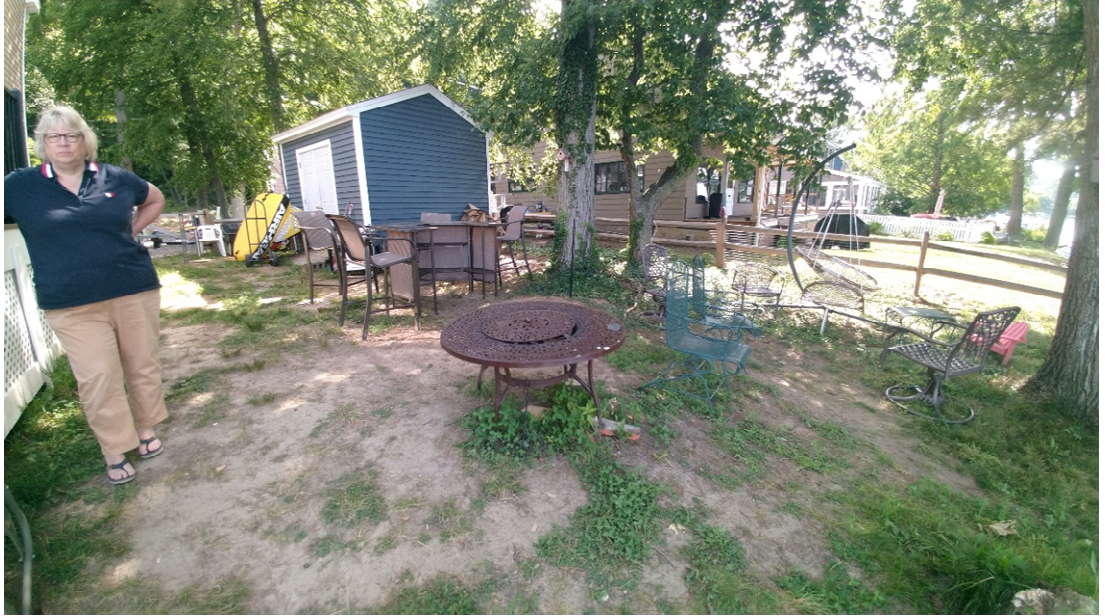
<b>Client Name:</b> Robert Manseau		<b>Site Location:</b> 54 Lake Attitash Road Amesbury, Massachusetts	<b>Project No.</b> 01.0175290.00
<b>Photo No.</b> 5	<b>Date:</b> 8/17/21

<b>Direction Photo Taken:</b> East			
<b>Description:</b> View towards Lake Attitash Road and area of proposed pervious paver installation.
